Manhole Inspection Summary

Manhole # S41II_033MH

Insp Date: **12/20/07 2:16 PM**

Location Address: **1501 LANVALE ST**

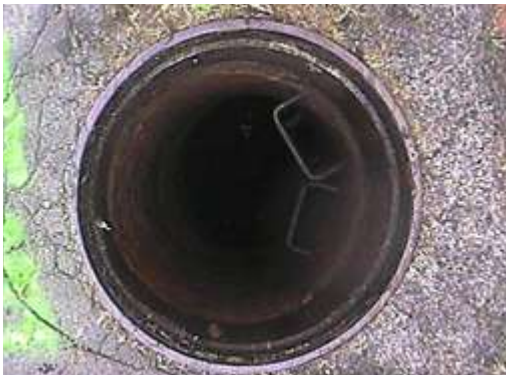
Defect 1

Offset: **1** (in.)

FRAME OFFSET

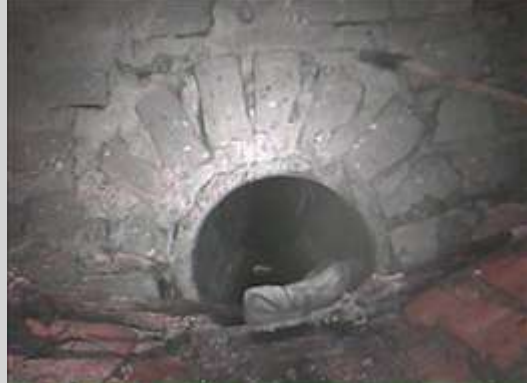
12 O'Clock Outflow

8 in. Circular Gravity Sewer
Pipe Out @ 12 O'Clock

Pipe Material: **Clay** ☐ Pipe Lined

Infiltration: **None** Pipe Seal Cond: **Sound**
